# Inspection Report

Prepared For:  
MOUNTAIN HOME

Property Address:  
475 LUMBER JACK LANE  
ESTES PARK, CO 80517

<b>Date:</b> 9/11/2006	<b>Time:</b> 10:08 AM	<b>Report ID:</b> 060911
Property: 475 LUMBER JACK LANE ESTES PARK, CO 80517	Customer: MOUNTAIN HOME	Real Estate Professional: LISA BON VARGAR PRUDENTIAL

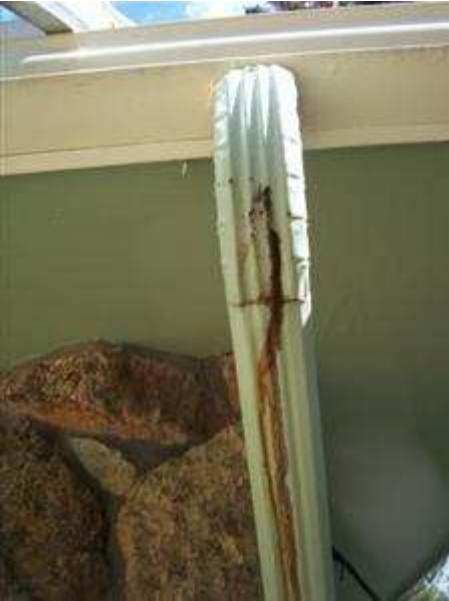
1.5 Picture 1

(Picture 1) Downspout is deteriorated at front right corner of home. Loose or leaking gutters can cause deterioration of fascia, soffit or roof edge. It can also cause gutters to pull loose and lead to possible water intrusion. Please follow through to make sure the work is completed.

(Picture 1) Downspout is deteriorated at front right corner of home. Loose or leaking gutters can cause deterioration of fascia, soffit or roof edge. It can also cause gutters to pull loose and lead to

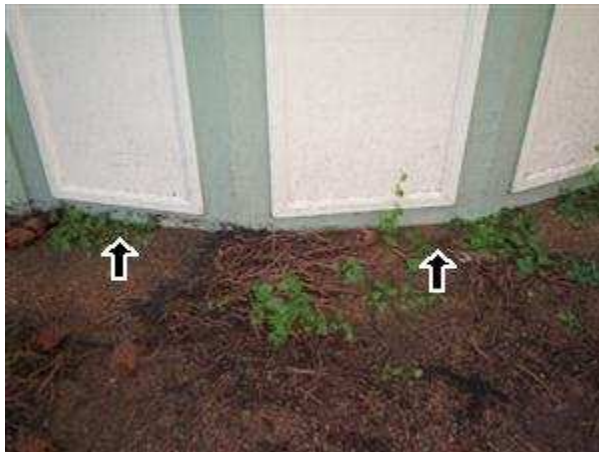
2.1 Picture 1

(Picture 1) Siding in contact with ground at "All of exterior in areas. Recommend a ground clearance of six to eight inches where possible.

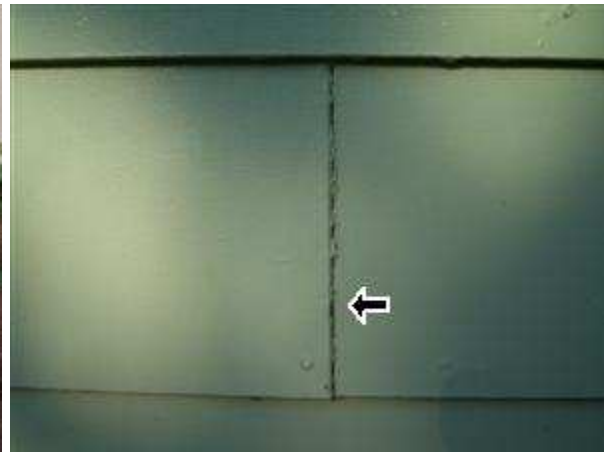
2.1 Picture 2

(Picture 2) The butt joints of the siding need caulk and paint to prevent further damage.

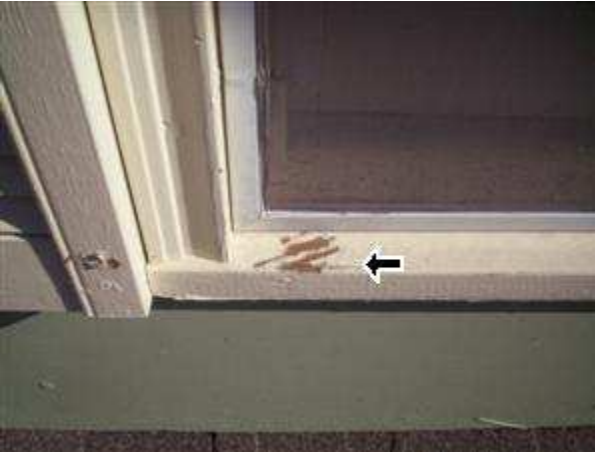
2.2 Picture 1

Window frame peeling paint at all or most windows. Further deterioration may occur if not repaired. Please follow through to make sure the work is completed.

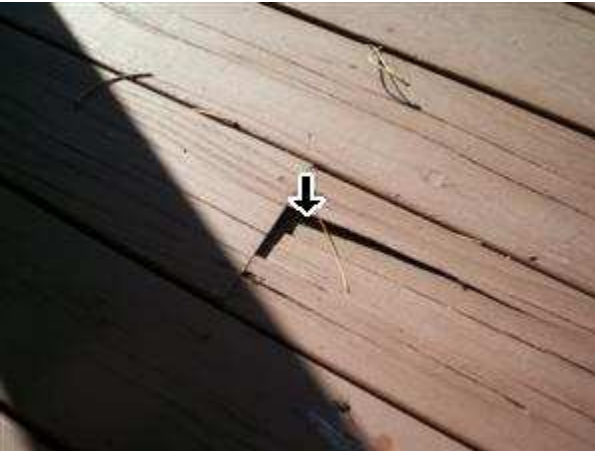
2.4 Picture 1

2x6 decking on Deck at front of home has deteriorated at end cut. Further deterioration can occur if not repaired. Recommend repair as needed. (Picture 2) Deck Band is not attached properly to the wall or band of home. It should have 5/8" galvanized "Lag Screws" or "Carriage Bolts" approximately every 36 inches.

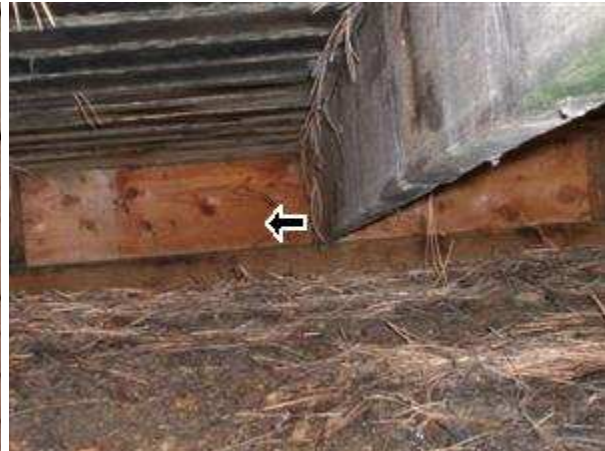
2.4 Picture 2

2x6 decking on Deck at front of home has deteriorated at end cut. Further deterioration can occur if not repaired. Recommend repair as needed.(Picture 2) Deck Band is not attached properly to the wall or band of home. It should have 5/8 galvanized"Lag Screws" or"Carriage Bolts" approximately every 36 inches.

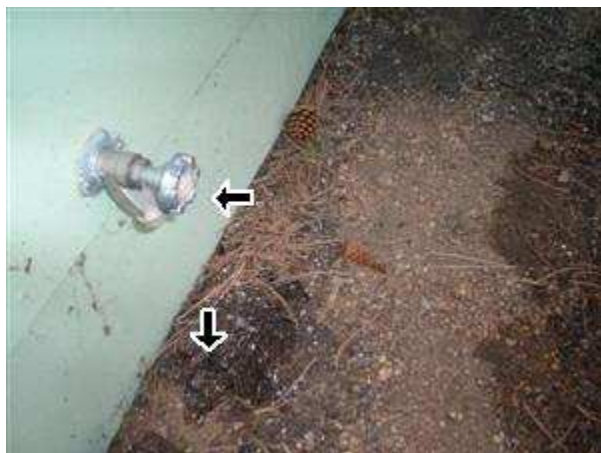
2.5 Picture 1

(1) (Picture 1) Hose bibs should have a splash block under them to divert water at least 5 feet away from the foundation.

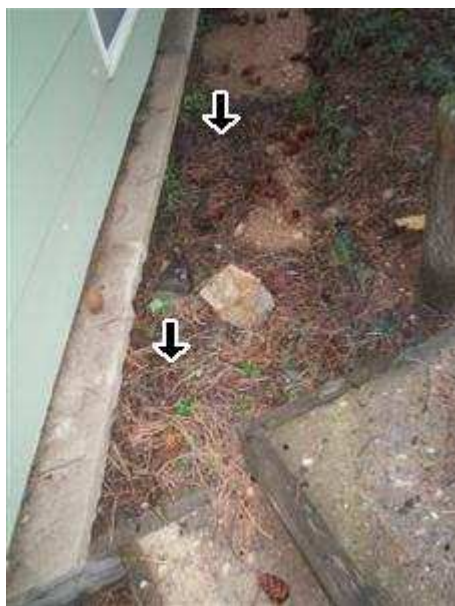
2.5 Picture 3

Corrective drainage is necessary to prevent water from entering the rear patio at the steps (Picture 4) and the rear wall (Picture 3). Water is infiltrating into the crawlspace. Recommend installing a drainage system to keep water from causing further damage.

Corrective drainage is necessary to prevent water from entering the rear patio at the steps(Picture 4) and the rear wall(Picture 3). Water is infiltrating into the crawlspace. Recommend installing a drainage system to keep water from causing further damage.

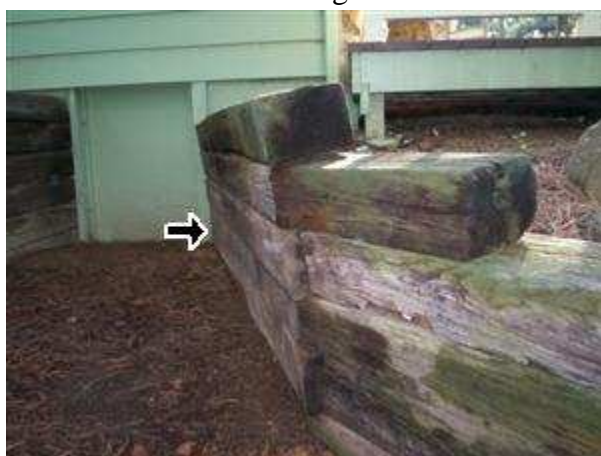
2.5 Picture 5

(2) Retaining wall is leaning and erosion signs are present. This problem will continue to become worse and needs correcting.

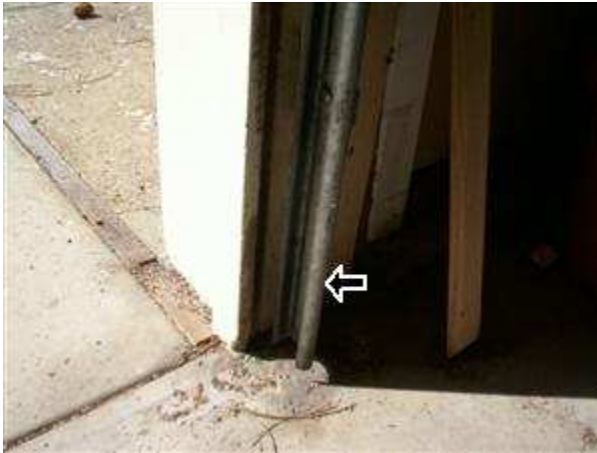
3.0 Picture 1

Sensors are not installed. This is a safety issue and should be repaired.

Garage Door will reverse when met with resistance.

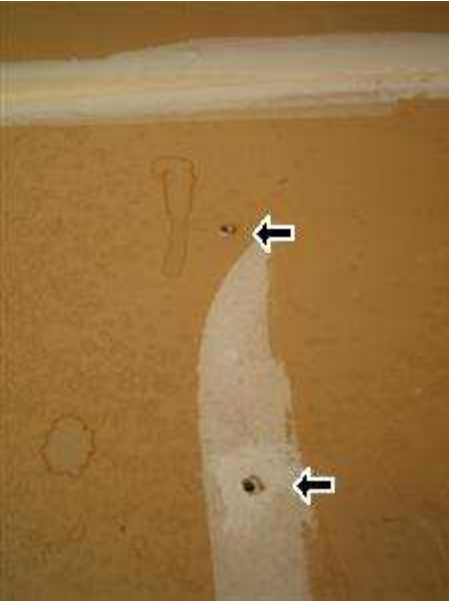
3.2 Picture 1

Sheetrock on wall has hole(s) at garage. This is a fire safety defect. A one hour fire wall is required.. Recommend repair or replace as needed using a qualified person.

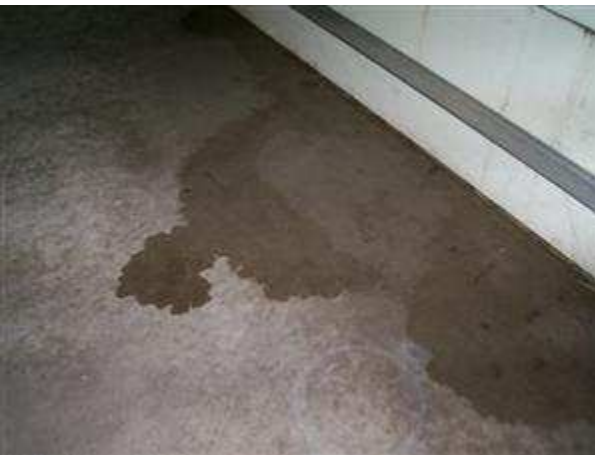
3.3 Picture 1

Water drains into the garage at the garage door.

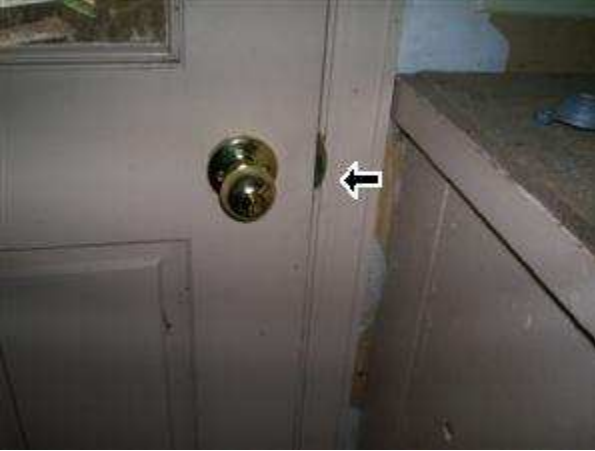
3.4 Picture 1

Door to outside needs doorknob and hardware repaired or replace to work properly at garage. This is a maintenance issue and is for your information. Recommend repair or replace as needed using a qualified person.

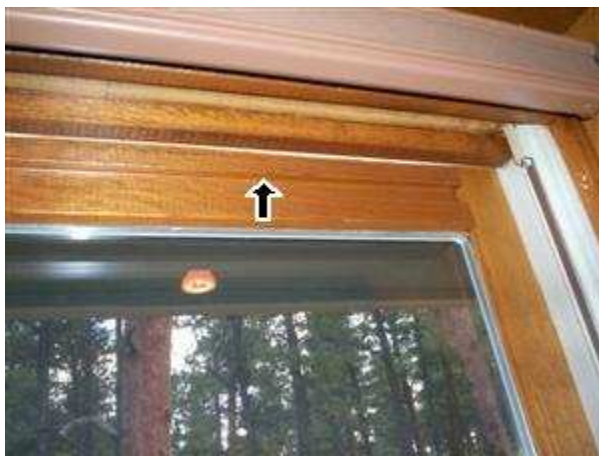
5.4 Picture 1

(Picture 1) Some windows stuck or painted shut at all or most rooms throughout house. This is a maintenance issue. Recommend repair or replace as needed using a qualified person.

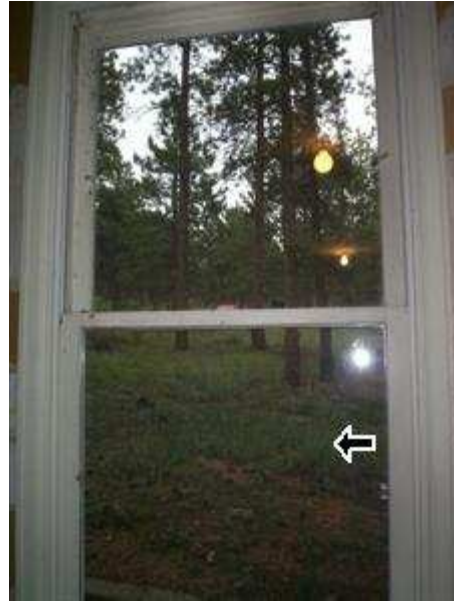
5.4 Picture 2

(Picture 2) One window is cloudy (lost seal) at Living Room. Other windows of this age could also have this defect and go unnoticed when or if moisture builds up. The major temperature changes here in Colorado contributes greatly to the failure of the seals. Other window may fail in the near future. Recommend having all the window checked by a qualified professional.. Recommend repair or replace as needed using a qualified person.

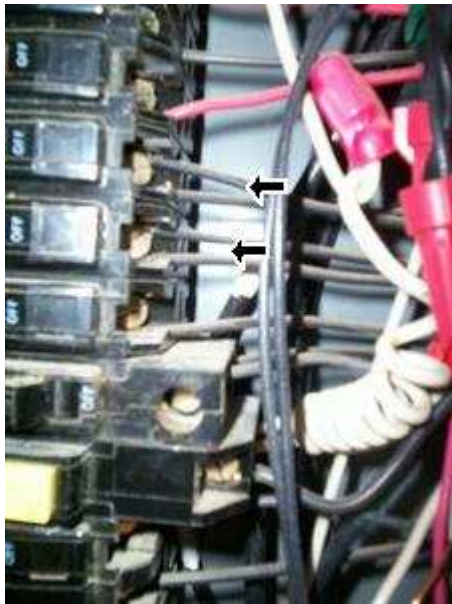
7.2 Picture 1

Problem(s) discovered with Branch Circuits such as Doubled wiring at circuit(s), and any other problems that an electrician may discover while performing repairs need correcting. Recommend a licensed electrician inspect further and correct as needed.

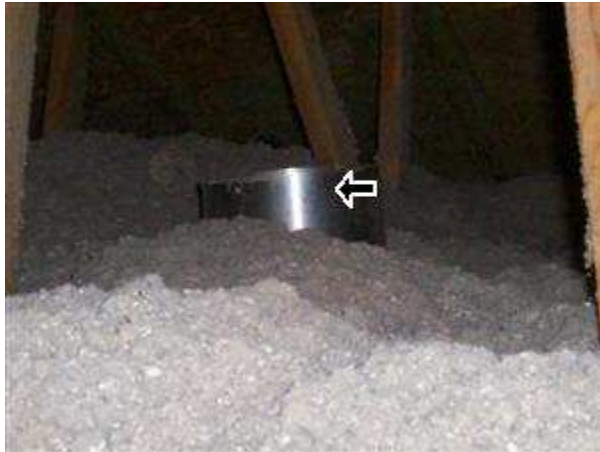
7.8 Picture 1

(1) Exhaust fan vents into attic. at Upstairs Bath. Vent pipes should terminate outside and not in the attic. Many homes have their vent pipe poised at the roof vent such as yours. It is up to you to determine whether or not this is a concern or needs further consideration from a general contractor. Recommend repair or replace as needed using a qualified person.

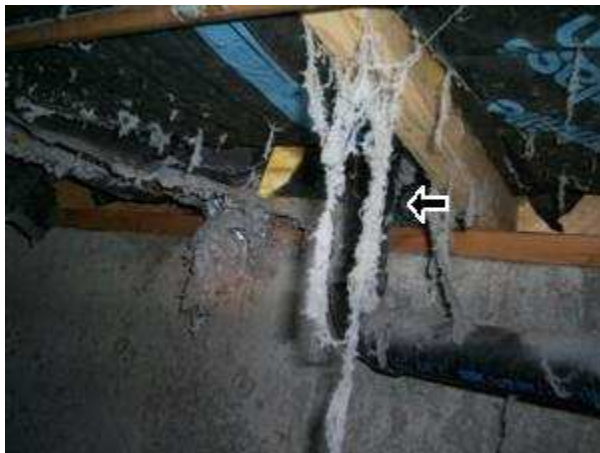
7.8 Picture 2

(2) Dryer Vent piping vent into the crawlspace and should vent to the outside.

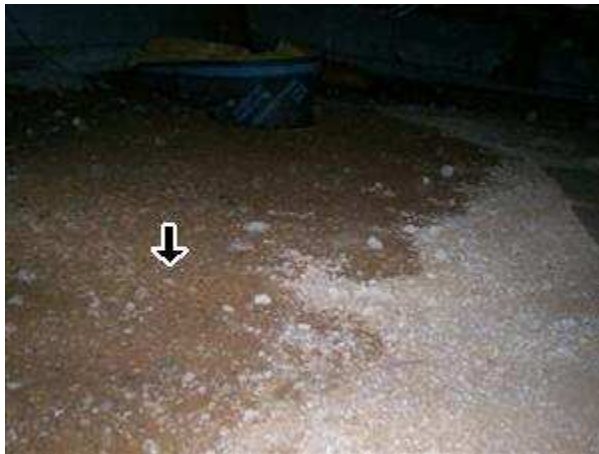
8.0 Picture 1

Visible signs of water intrusion in crawlspace are present from dampness at ground. Water intrusion if not corrected can lead to other problems including mold and cause excessive moisture to floor system that can lead to deterioration and increased repair cost.. Sloping the ground or trenching may be needed to direct water . Recommend further investigation or correction by a qualified licensed contractor or water infiltration specialist.

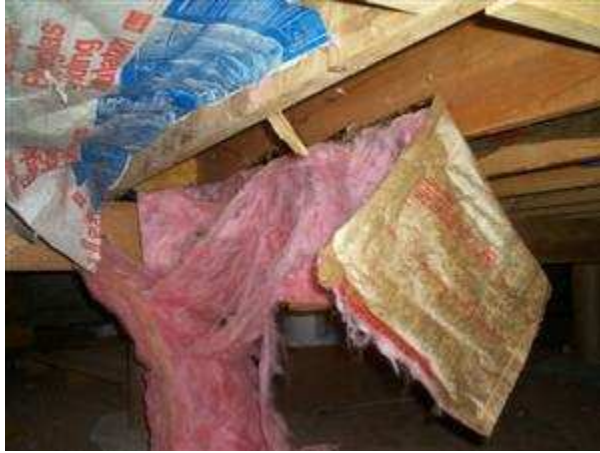
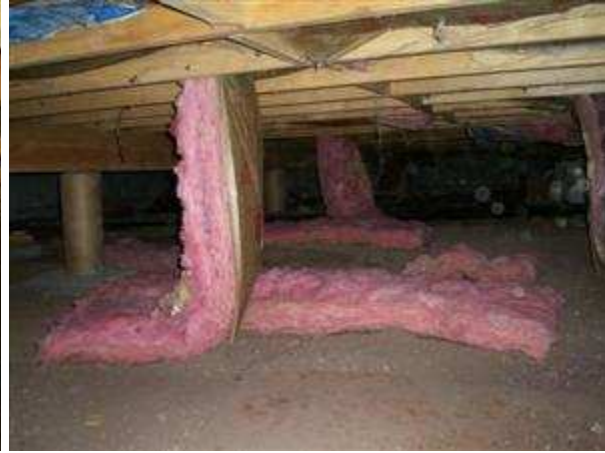
Insulation is loose/fallen and installed wrong side up in crawlspace. Insulation that has fallen to the ground or has become damp from the ground or from condensation usually needs to be replaced

with new insulation .. Recommend repair or replace as needed using a qualified person.

Vapor barrier (plastic) on crawlspace ground is missing. A vapor barrier provides added protection to floor system from moisture or dampness that can enter from ground. Recommend repair or replace as needed using a qualified person.

Insulation is loose/fallen and installed wrong side up in crawlspace. Insulation that has fallen to the ground or has become damp from the ground or from condensation usually needs to be replaced with new insulation .. Recommend repair or replace as needed using a qualified person.

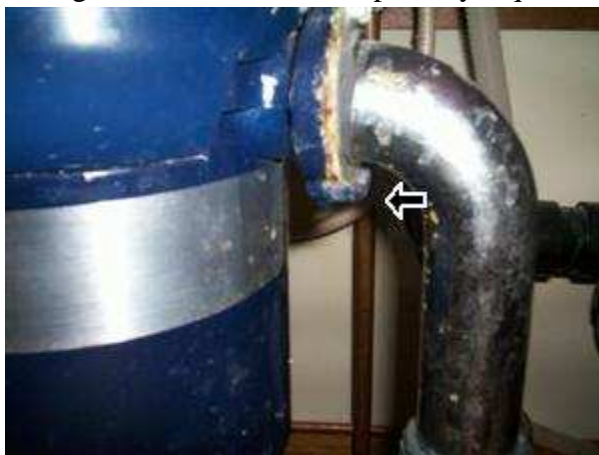
9.1 Picture 1

Waste line is leaking at sprayer connection and the garbage disposal. Repairs are needed to stop leaking water from damaging the cabinet bottom or to eliminate moisture that may contribute to mold growth. Recommend repairs by a qualified person.

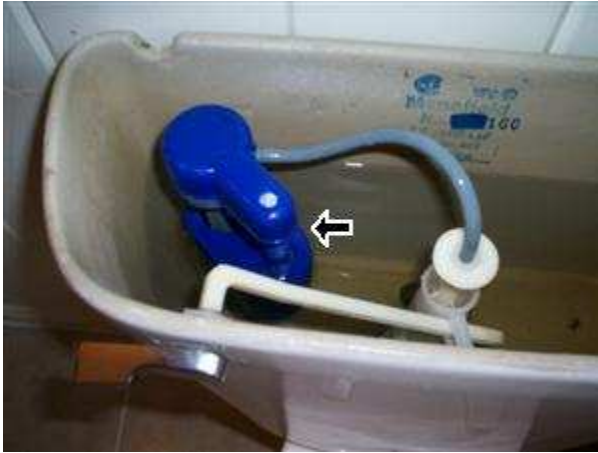
9.2 Picture 1

Toilet runs continually at Upstairs Bath. Repairs are needed. Recommend repairs by a qualified person.

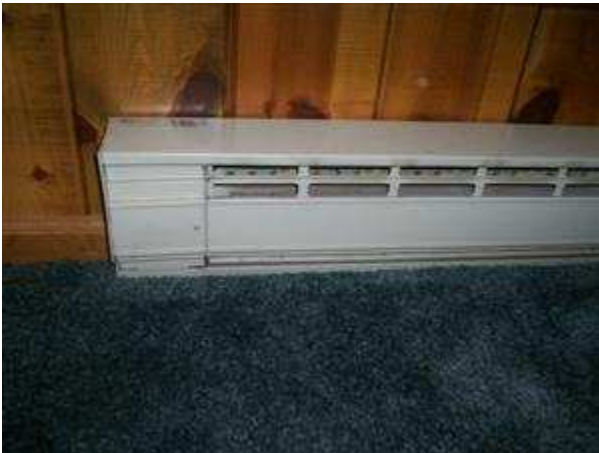
10.0 Picture 1

Several electric base board heaters do not operate. Recommend a licensed HVAC or electrician to repair.
