HomeFront Inspection, LLC

Home
1234 Roof Leak Pl
New Home, CO 80209

Saturday, January 10, 2004

HFI-00000

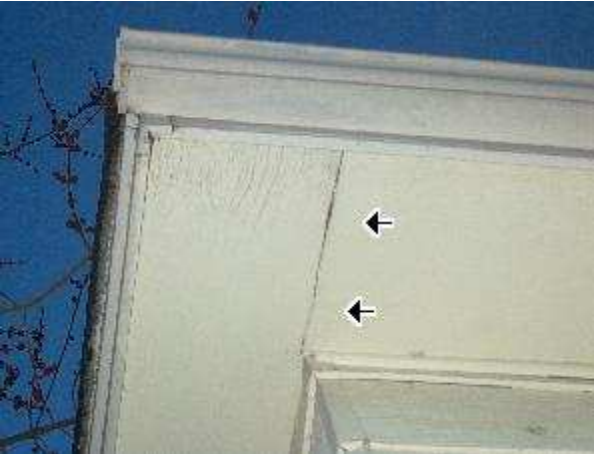
2.0 CONDITION OF SOFFIT, FASCIA, TRIM AND EAVES

Comments: REPAIR OR REPLACE

Paint failing on eave. Needs prep and paint at front of home and rear of home.

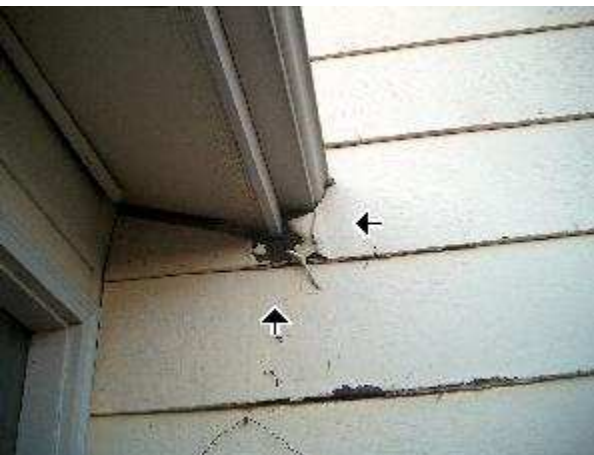
2.1 CONDITION OF EXTERIOR WALL COVERINGS, FLASHING

Comments: REPAIR OR REPLACE

Paint failing on siding. Needs prep and paint at all areas of exterior.

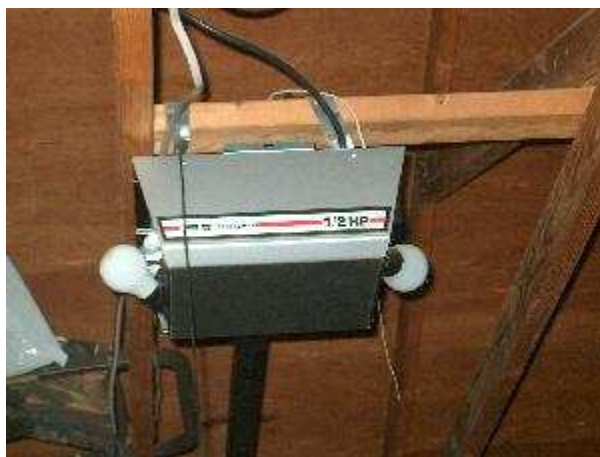
5.0 GARAGE DOOR OPERATORS

Comments: Yes, REPAIR OR REPLACE

Automatic opener for Garage door at front of home will not reverse when met with resistance.
