# Inspection Report

Property Address:  
7417 INSPECTOR DR  
LITTLETON, CO 80123

## HomeFront Inspection, LLC

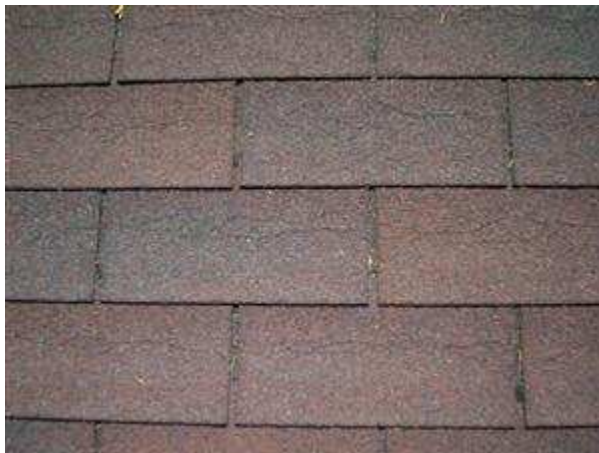
1.0 Picture 1

Two layers of shingles are present. Some areas Code allows up to three layers. One more layer may be added before tear-off is required. However this may be too much weight for the rafters and cause rafters to sag or break. Tare off will add to the cost of re-roofing considerably. Other problem my be detected when sheathing is exposed. Additional cost could occur if other defects are discovered. Recommend contacting a professional in this area.

(Picture 1) The roof covering is old, and near the end of its life. The covering may need to be replaced within 5 years.

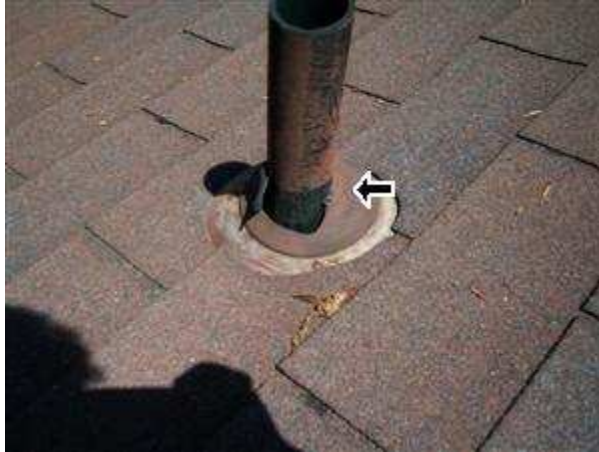
1.2 Picture 1

Plumbing vent pipe (through roof) needs flashing boot replaced (All the vents various diameter) on front of home and rear of home. This area can leak if not corrected. Recommend repair or replace as

needed . Recommend replacement when new roof is installed.

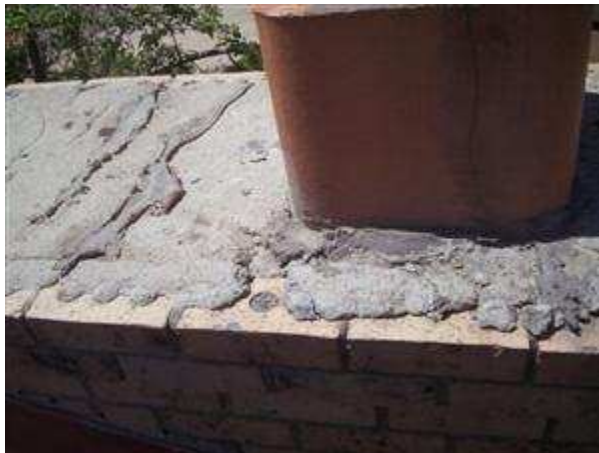
1.2 Picture 3

(Picture 3) The cement cap on the chimney has deteriorated and needs repaired. Further damage will occur if not repaired. Recommend repair or replace by a qualified person.

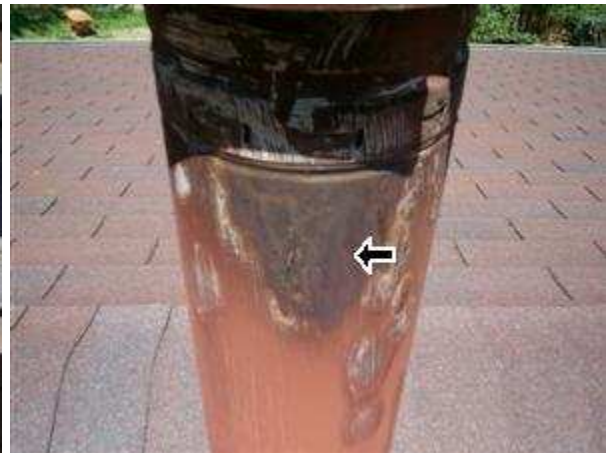
1.2 Picture 4

(Picture 4) The metal furnace vent is rusted and needs replacing.

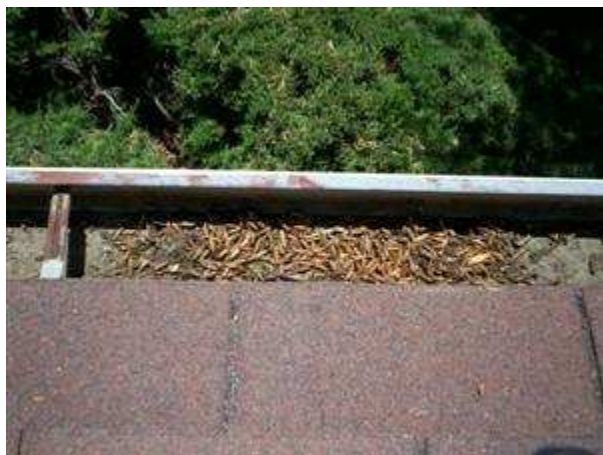
1.4 Picture 1

Gutter needs cleaning of debris at front (left of main entry). Gutters that drain poorly or clogged can lead to many costly problems such as deterioration of fascia, soffit or roof edge. It can also cause gutters to pull loose and lead to possible water intrusion. Please follow through to make sure the work is completed.

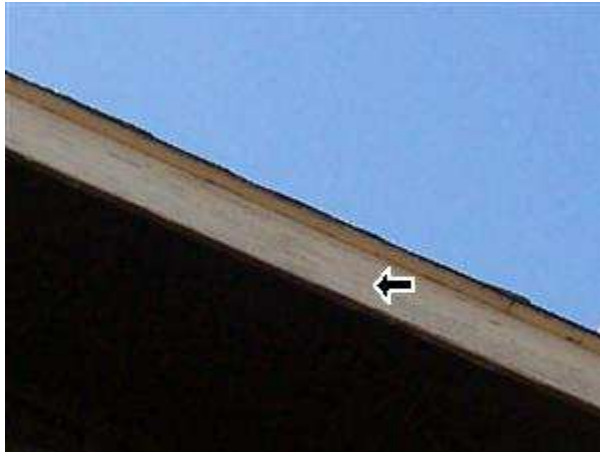
2.0 Picture 1

Paint failing on eave. Needs prep and paint at "All" of exterior.

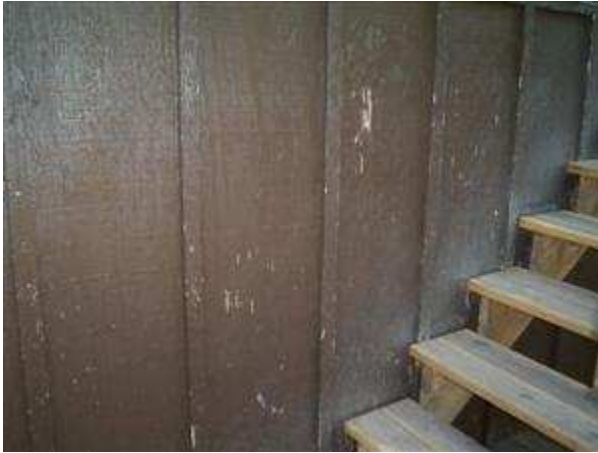
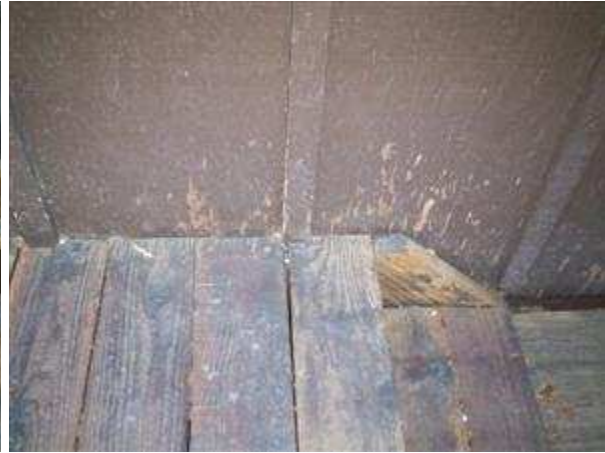
2.1 Picture 1

Paint failing on siding. Needs prep and paint at "All" of exterior.

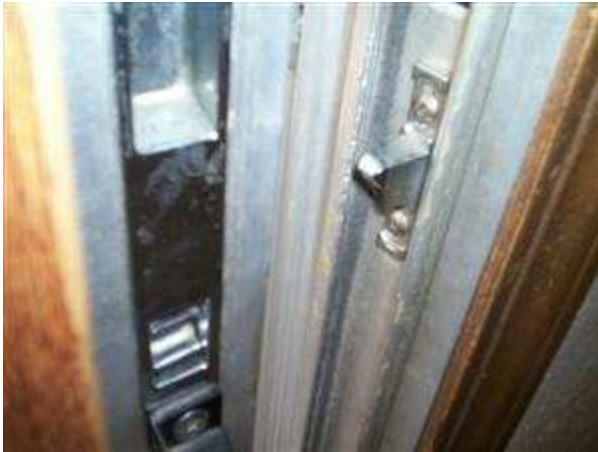
2.3 Picture 1

Sliding glass doors at Rear entry door does not lock. This is considered unsafe and needs correcting. Recommend repair or replace as needed using a qualified person.

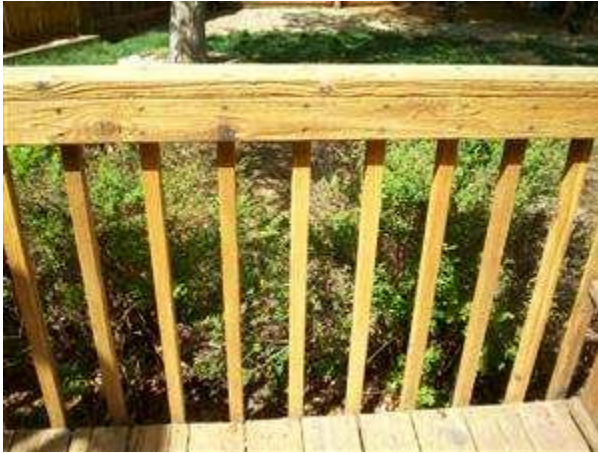
2.4 Picture 1

(Picture 1) Pickets on Upper level balcony at rear of home are spaced too far apart for safety. Pickets more than 4 inches apart could allow an adult, child or pet to fall through. Recommend maximum space between pickets to be four inches.

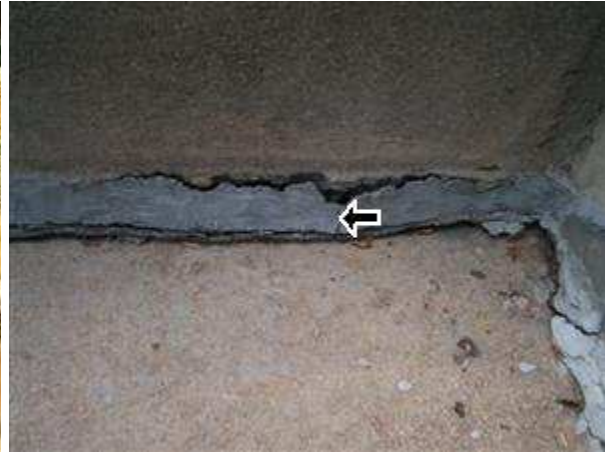
2.4 Picture 2

The front steps have settled and pulled away from the porch. This area should be properly repaired with cement or mud jacking.

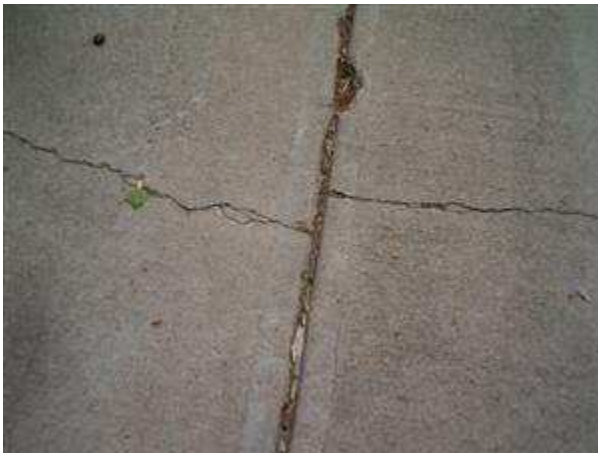
2.5 Picture 1

Concrete drive at front of home has settlement cracks. Water can cause further deterioration if not repaired and sealed properly. Recommend repair or replace as needed using a qualified person.

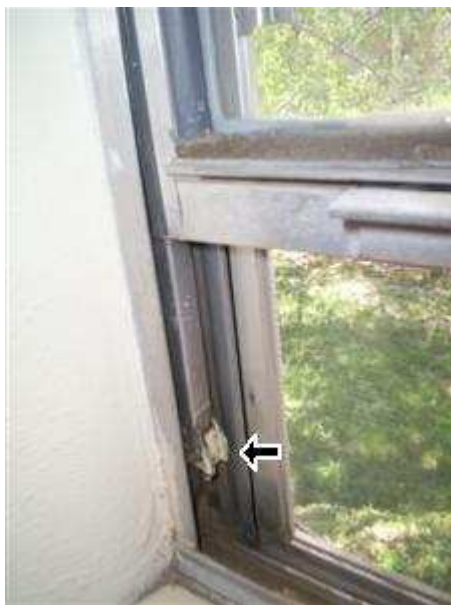
5.4 Picture 1

The window has a damaged sash spring in the dining room. Recommend repair or replace by a qualified person.

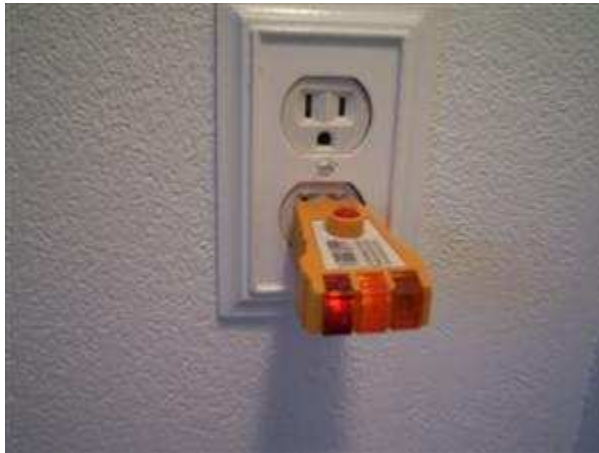
6.6 Picture 1

Outlet(s) are outdated and need to be updated to GFCI. This is for your safety. Contact a licensed electrician to install.

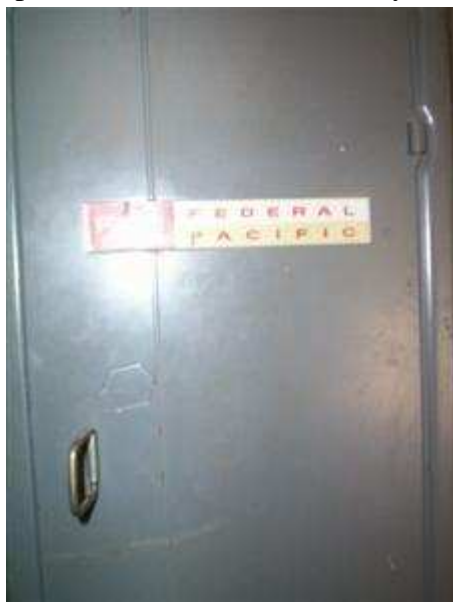
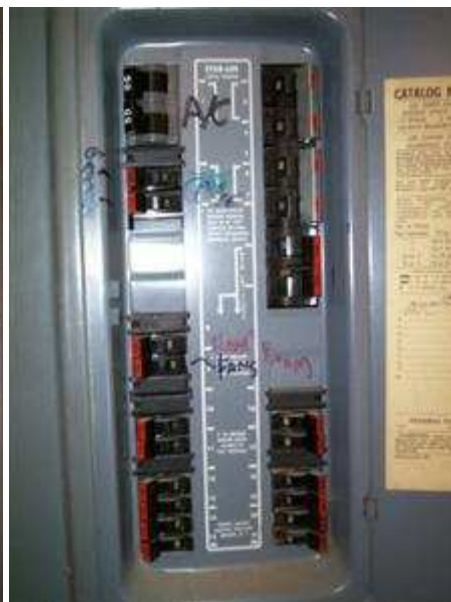
7.1 Picture 1

You have a Federal Pacific panel which is legal, but there is a possibility that the circuit breakers may not trip when shorted possibly causing an electrical hazard. Opinions by licensed electricians on this panel varies between safe and unsafe. I recommend you consult a licensed electrician for an opinion and correct if necessary.

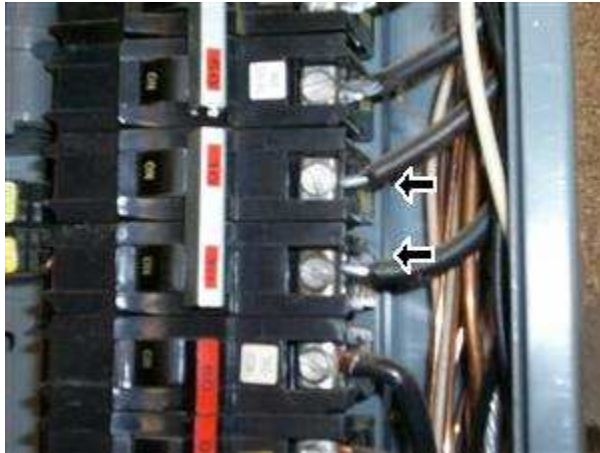
7.2 Picture 1

Problem(s) discovered in panel such as Aluminum branch wiring, (Two 10 gage wire) and knock

out missing and any other problems that an electrician may discover while performing repairs need correcting. Recommend a licensed electrician inspect further and correct as needed.

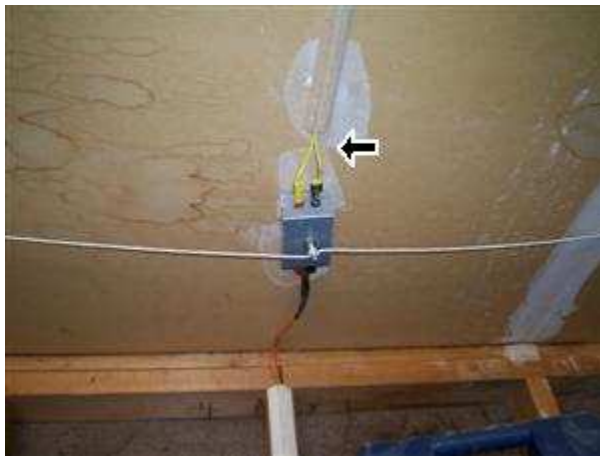
7.3 Picture 1

Improper wiring at light fixture in garage. Electrical issues are considered a hazard until repaired. Recommend a qualified licensed electrician perform repairs that involve wiring. Other defects may be discovered that only a licensed professional can discover. These too should be repaired. .

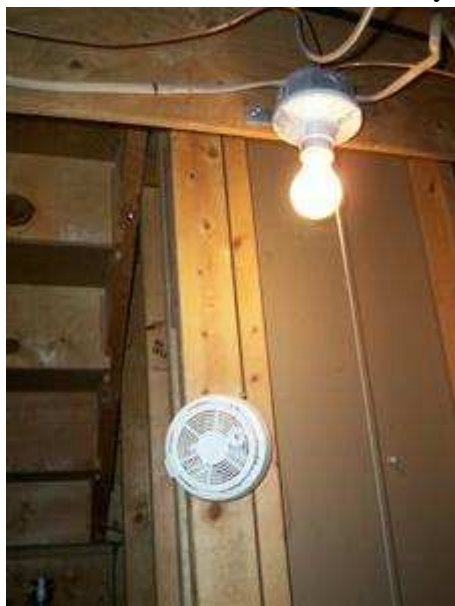
7.8 Picture 1

Smoke detector did not work when tested at hallway. Without a working smoke detector in your home you have no first alert to a possible fire. Please follow through to make sure the work is completed.(Picture 1) Smoke detector needs locating at least 4 inches from ceiling/wall junction and no further than 12 inches away.

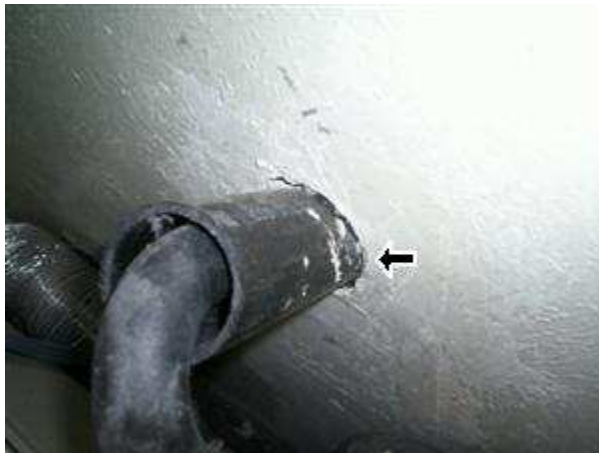
9.1 Picture 1

(Picture 1) The stand pipe for the washing machine is loose at the wall. Recommend caulking around the pipe and wall to secure it.

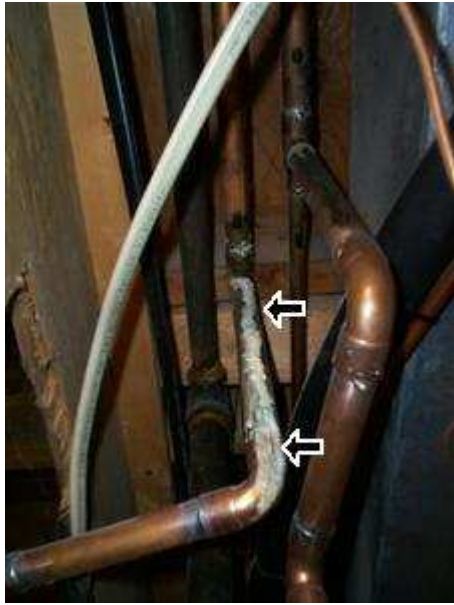
9.2 Picture 1

(Picture 1) The water line above the water heater is rusted possibly from a leak in the pipe that has

sealed its self. Recommend a licensed plumber to inspect and repair.

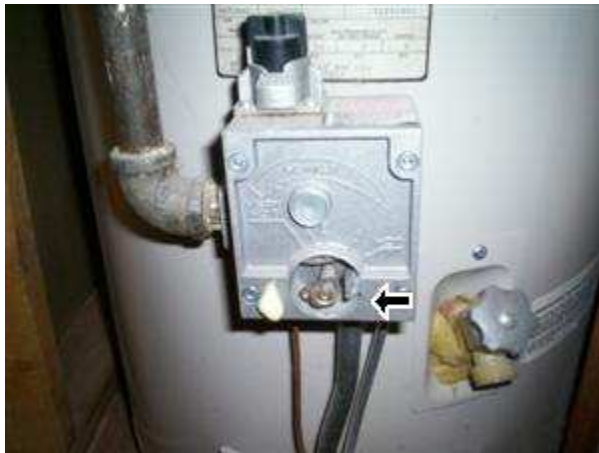
9.3 Picture 1

(Picture 1) The water heater is missing the control knob.

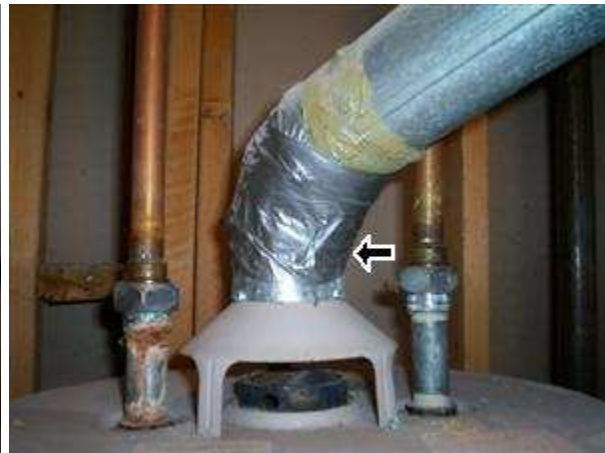
9.3 Picture 2

(Picture 2) The vent pipe for the water heater is wrapped with duct tape. This is tape is not fire rated and needs to be replaced.

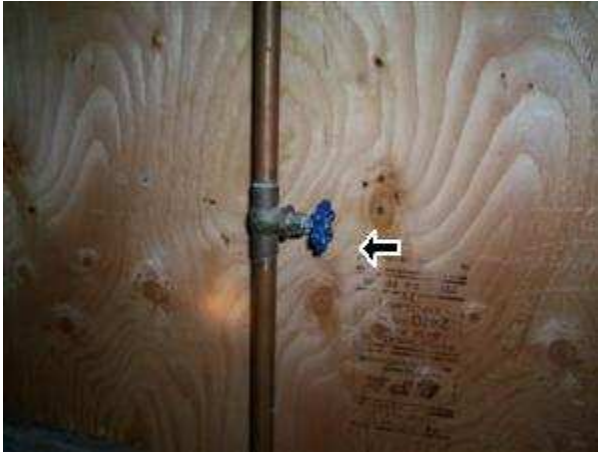
9.4 Picture 1

The main shut off is the blue knob located under stair well. This is for your information.

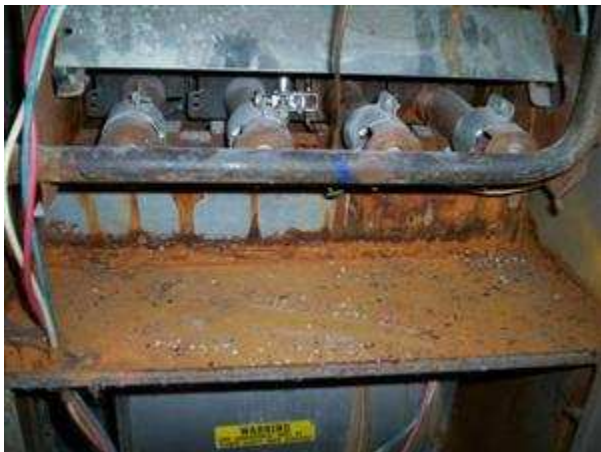
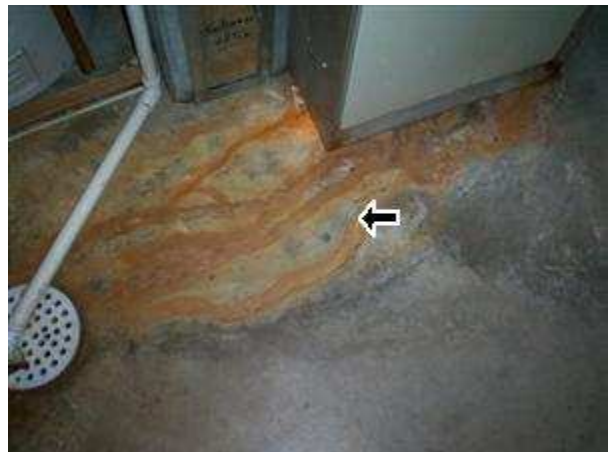
10.0 Picture 1

(Picture 1) (Picture 2) The furnace burner area and cabinet is rusted. It appears that the air conditioner is or was leaking and caused this rust. Recommend a HVAC professional to repair and certify.

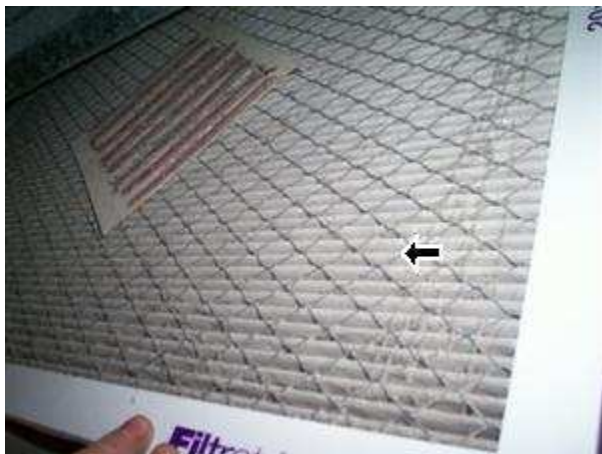
10.4 Picture 1

The filter for the furnace is **clogged** and needs replacing. Also, a clogged filter often collapses and allows unfiltered air into the ductwork. Recommend contacting a Duct cleaning professional as desired. Air filters should be replaced monthly. A good way to remember to replace the filter is when you pay your monthly utility bill.

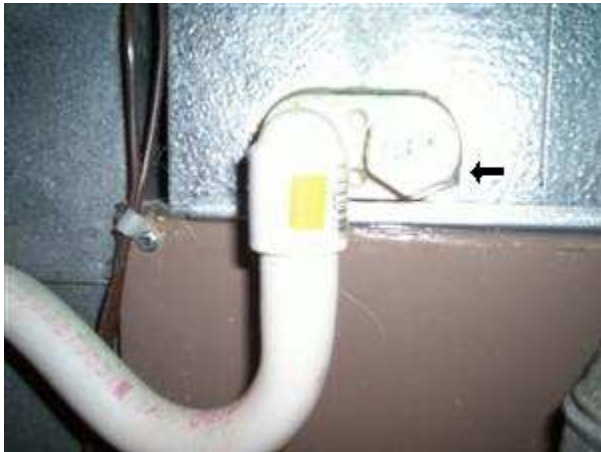
11.0 Picture 1

The condensate line may be leaking and causing the furnace to rust.

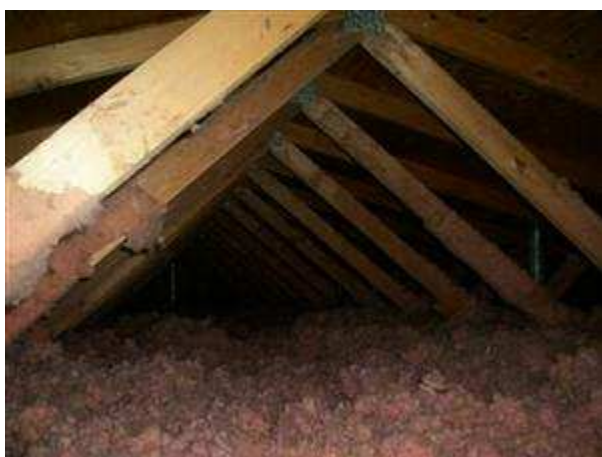
12.3 Picture 1

(Picture 1) Fiberglass (loose-fill) insulation is needed and needs to be leveled to a uniformed thickness in attic. Heat loss can occur more on this home than one that is properly insulated. Recommend adding insulation to a at least R-30. About 10 to 12 inches.

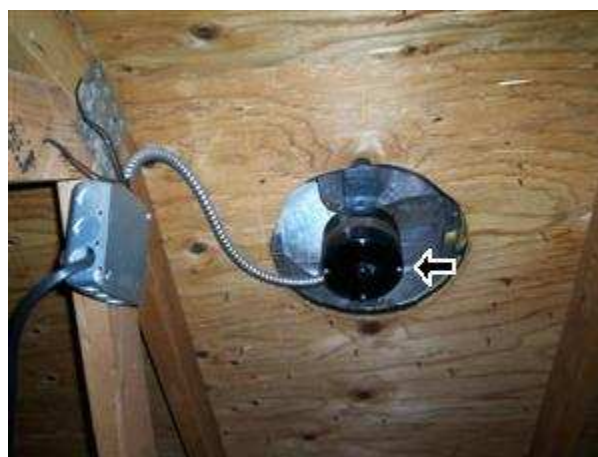
12.3 Picture 2

(Picture 2) Thermostatically controlled vent fan in attic appears defective. Attic was hot but fan was not working. Recommend repair or replace as needed using a qualified person.
